COMBINED PRELIMINARY ASSESSMENT/SITE INSPECTION REPORT

**Camdenton Sludge Disposal Area Site
Camden County, Missouri**

March 30, 1999

**Missouri Department of Natural Resources
Division of Environmental Quality
Hazardous Waste Program**

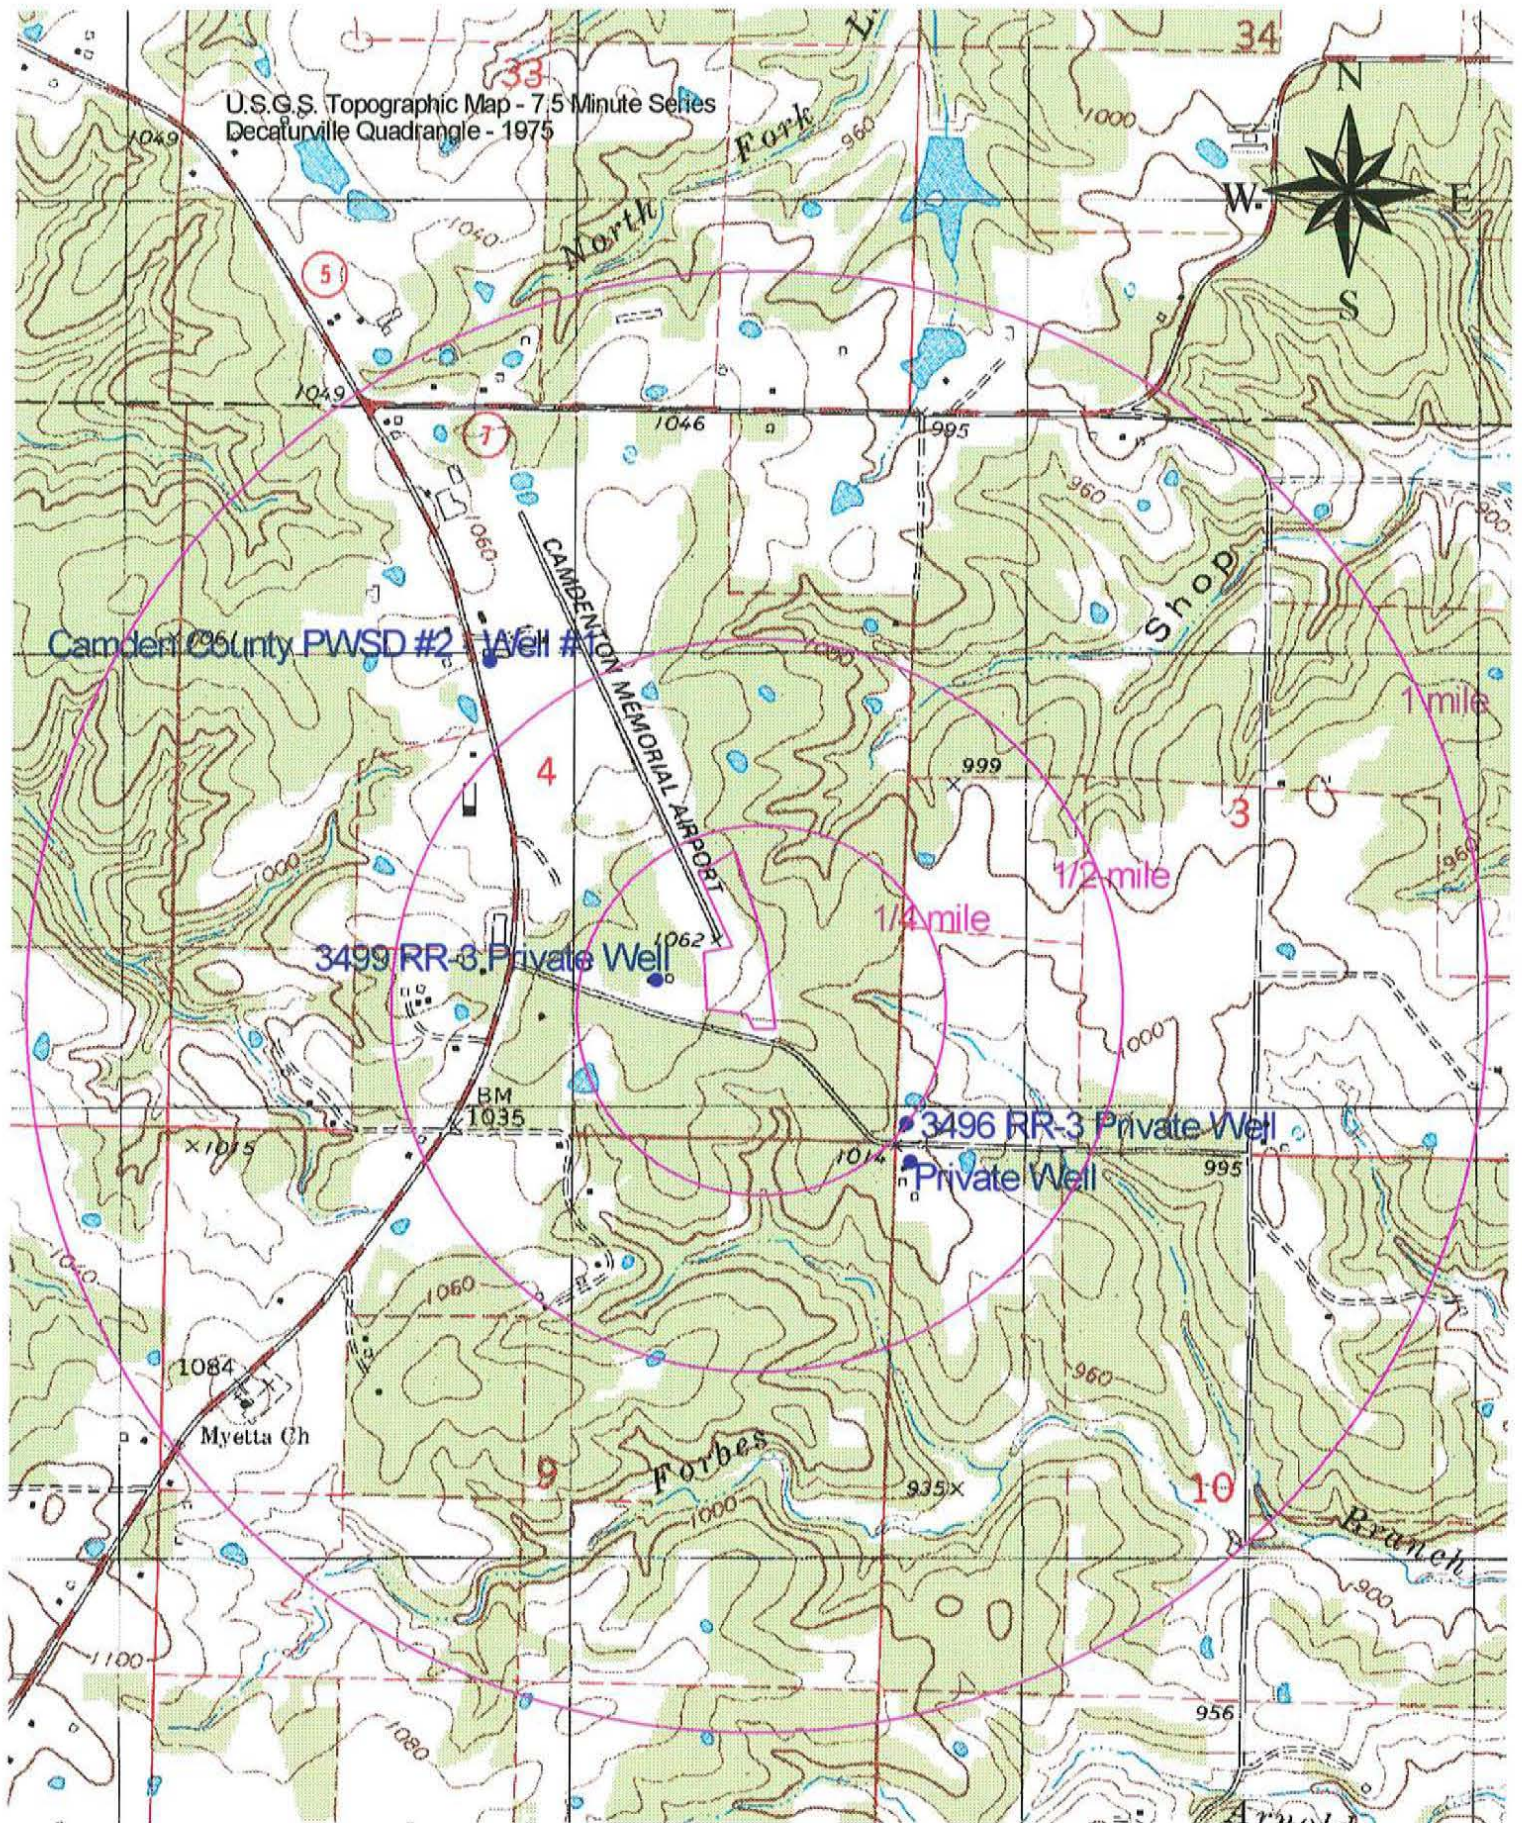
Figure 2: Camdenton Sludge Disposal Area
Soil Sampling Locations

- ▲ MIP/Soil boring location/identification
- ⊙ Well location
- 99XXXX Sample collected at location indicated

PA/SI soil sampling in the sludge disposal area was conducted on January 22, 1999. Figure 2 in Appendix A is a site map that shows collection location of all soil samples collected in the sludge disposal area. A membrane interface probe (MIP), equipped with a photo ionization detector (PID) and a flame ionization detector (FID), was employed to generate soil gas data of the subsurface within and surrounding the boundaries of the former lagoon area. The soil gas data was used, in part, to determine actual sampling locations.

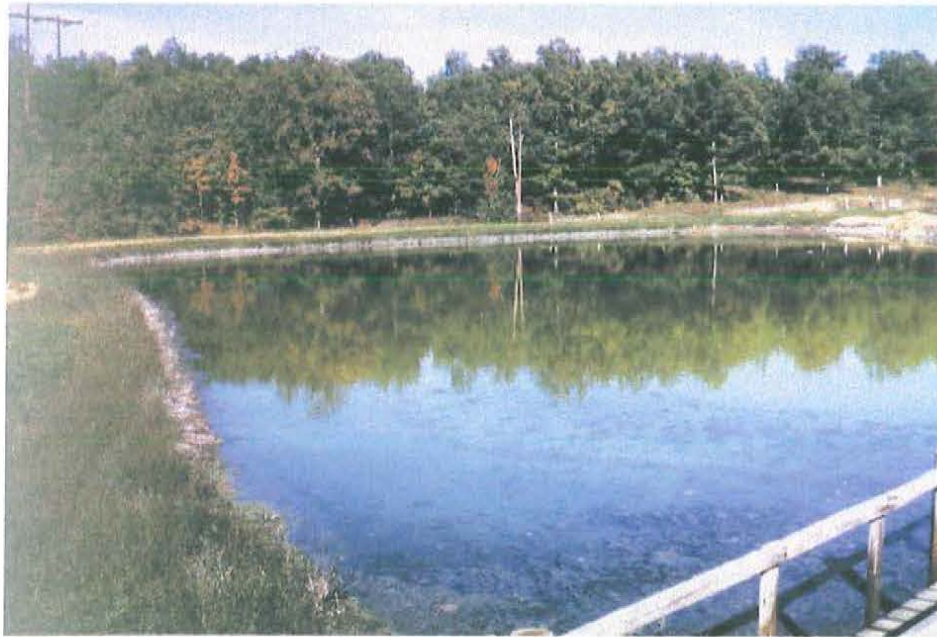
PHOTO 1

Former Hulett Lagoon Site. Camdenton, MO, Camden County. Photo taken on 10/1/74 by Ronnie Testerman, MDNR, JCRO. View looking northeast at the Hulett lagoon during operation. The northern portion of the lagoon shown in the photo was where influent from domestic sewage entered the lagoon. A small amount of the sludge from the Sundstrand influent, which came in on the south portion of the lagoon can be seen in the foreground of the photo near the wooden catwalk.

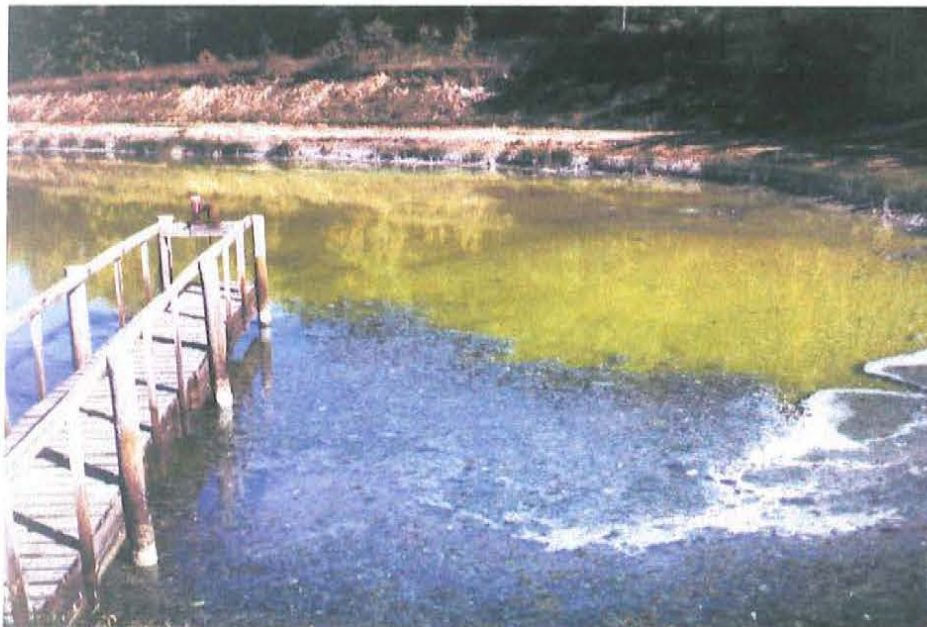
PHOTO 2

Former Hulett Lagoon Site. Camdenton, MO, Camden County. Photo taken on 10/1/74 by Ronnie Testerman, MDNR, JCRO. View looking east at the Hulett lagoon during operation. The picture was taken to show the sludge settling around the influent pipe area from Sundstrand.

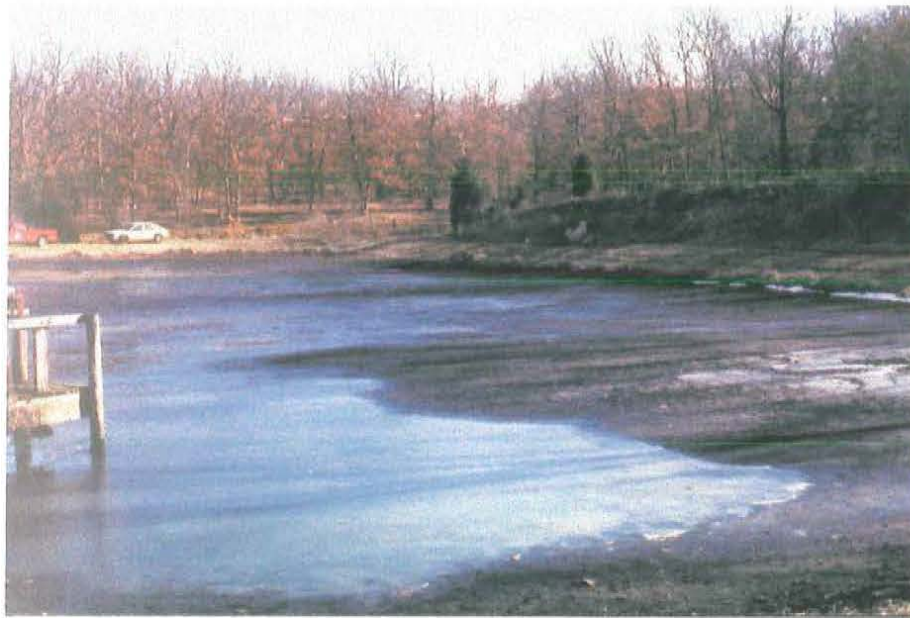
PHOTO 3

Former Hulett Lagoon Site. Camdenton, MO, Camden County. Photo taken sometime in June or July 1989 by Ronnie Testerman, MDNR, JCRO. View looking northeast at the Hulett lagoon during the beginning of the closure process. The dewatering had begun, but no sludge had been removed.

The following description of the Hulett lagoon is included to provide pertinent background information. The former Hulett lagoon is a closed wastewater sewage lagoon that was operated by the City of Camdenton from 1961 to 1988. The lagoon was approximately one acre in size, located in the City of Camdenton, northeast of the intersection of Dawson Road and Sunset Drive. Photos 1 and 2 were taken in October 1974 when the lagoon was operating. Photo 1 shows the north side of the lagoon where an influent pipe from a city sewer line entered the lagoon. Photo 2 shows the south side of the lagoon where an influent pipe from an industrial facility entered the lagoon. A great deal of sludge settling around the influent is visible. In 1989, the lagoon was closed; the water was drained and the sludge was removed (Reference 9, p. 12). Photo 3 was taken during the dewatering process.
